December 2007

Technical Series 07-119

Monitored Thermal Performance of ICF Walls in MURBs

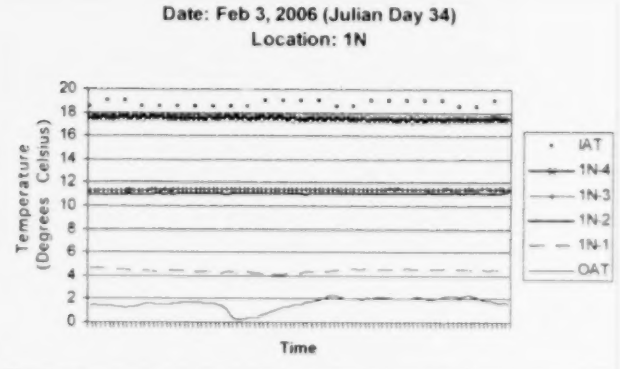
Figure 3 Quasi-steady-state wall performance

Figure 3 shows the through-wall temperature conditions at the first storey location on the north wall (1N) on February 3, 2006, when the wall was observed to be at a quasi-steady-state condition. The temperature difference across the inner (1N-4 to 1N-3) and outer (1N-2 to 1N-1) layers of insulation was approximately 6.3°C. By comparison, there was only a difference of 0.4°C across the concrete (1N-3 to 1N-2). This indicates that the concrete does not contribute significantly to the overall thermal resistance of the wall under steady-state conditions.

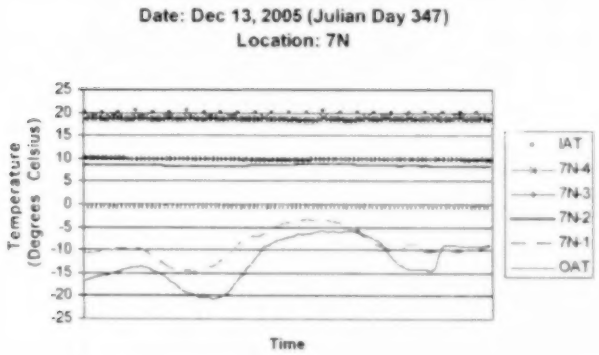
Figure 4 ICF wall isolating IAT from OAT

Figure 4 shows the wall conditions on the 7th floor, north wall location (7N) for a day with significant fluctuations in the outdoor air temperature (OAT). Not surprisingly, the temperature at 7N-1 (the exterior wall surface) closely follows the OAT; however, the temperature at the inner locations held constant throughout the day.

This indicates that the inner surface of the concrete (7N-3) is well isolated from outdoors temperature changes by both the insulation levels on the exterior of the wall and the capacitance of the concrete. The level of isolation is so large that what happens outdoors has almost no impact on the interior concrete temperature and therefore no significant impact on the heat flow through the wall from the interior in the short term (that is, daily or even weekly).

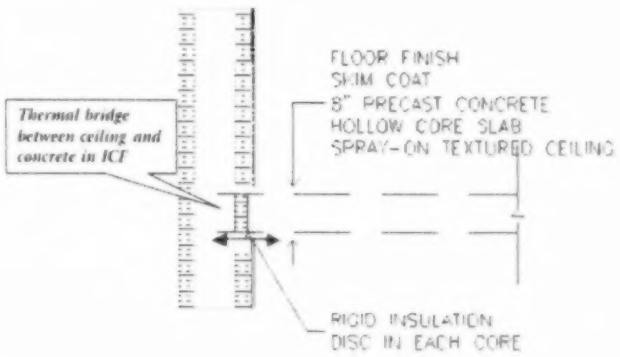
Figure 5 Thermal bridge at wall-floor slab intersection

An infrared thermographic survey of the building was also conducted to locate thermal bridges through the ICF wall assembly. The through-wall heating-cooling unit penetrations, window assemblies and balcony sliding doors exhibited expected thermal bridging. However, thermal bridging was also found at locations such as the wall–floor slab junction (see figure 5) where the temperature of the intersection was found to be 3˚C less than the adjacent opaque wall temperature. However, this would not likely have a significant impact on the overall building heating load.

Thermal bridge between ceiling and concrete in ICF
FLOOR FINISH
SKIM COAT
8" PRECAST CONCRETE HOLLOW CORE SLAB
SPRAY-ON TEXTURED CEILING
RIGID INSULATION DISC IN EACH CORE

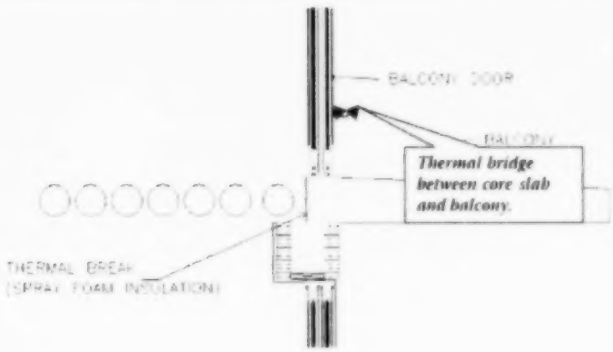
Figure 6 Construction detail showing thermal bridging at wall-balcony interesection

Thermal bridging was also detected where the balcony slabs intersect the ICF wall system. The temperature of the balcony near building (in front of the balcony door and at the intersection of the balcony and the exterior wall), was approximately five degrees warmer than the areas further away from the building even though there was a thermal break installed between the core slab and the balcony (see figure 6). No significant thermal bridging through the ICF wall itself was observed. This is due to the design of the ICF system, in which the plastic spanners within the ICF blocks do not fully penetrate either layer of insulation. In addition, the exterior layer of insulation is not totally breached at wall–floor intersections.
